PILLAI HOC COLLEGE OF ARCHITECTURE

Criteria 7 – Institutional Values and Best Practices

Criterion 7-Institutional Values and Best Practices

Green Audit Report

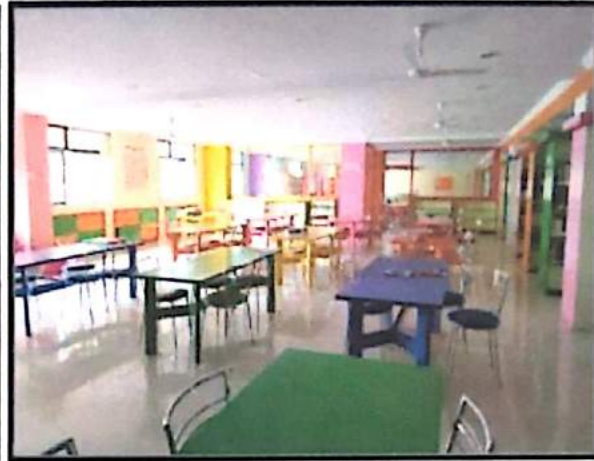
Good Day Light in Library

1. Few curtains need to be replaced

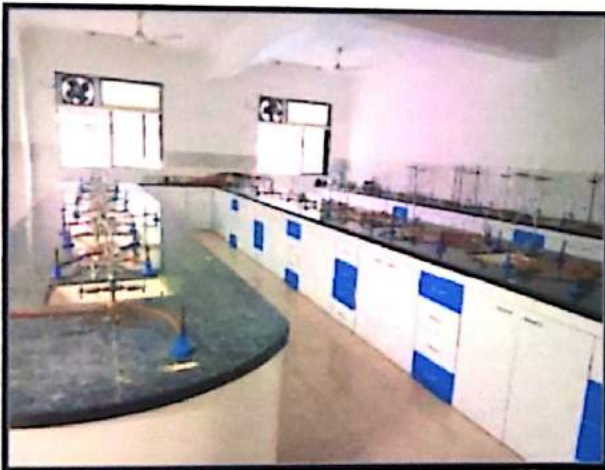
3. Chemical laboratory in the campus has exhaust to remove pollutants, allergens, fumes, odors and unwanted moisture. Campus Canteen also has exhaust.
4. Air Conditioners are installed in few labs and auditorium
5. Campus has Green belts within the campus.
6. Fire alarm is installed on each floor.
7. Few indoor plants are planted within the campus. The details of these plants are given in

Exhaust Fan in Chemical Laboratory and good ceiling height

1. Exhaust to be cleaned and maintained.
2. Exhaust fans are installed only in the chemistry lab. More exhaust needs to be installed.
3. Only a few indoor plants were observed within the campus. Few artificial plants were observed in the campus that could be replaced by indoor plants.
4. Smoke detectors need to be installed.

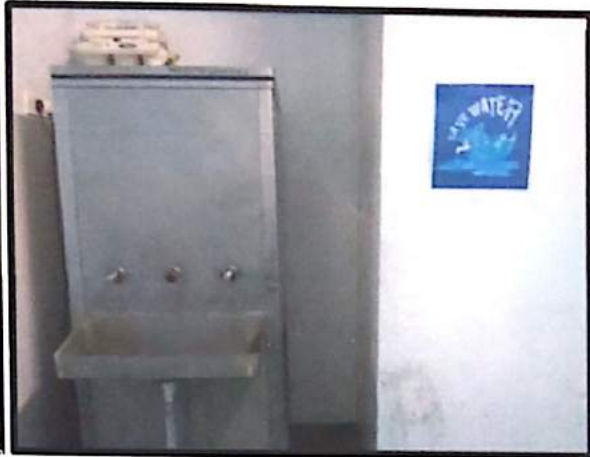
8. Water saver faucets are installed in few washrooms
9. Water leakages are attended and maintained on time by inhouse team.
10. Signages are provided at a few water points.

Signages near Cooler/Purifier

1. Water saver faucets need to be installed in every washroom.
2. Dual flushing should be provided in the washrooms to reduce 20% of water wastage.
3. Signages at every water supply point and washrooms required to emphasize on water conservation.
4. Water coolers which are not working need to be repaired
5. Water meters can be installed to quantify water consumption, depending on which proper measures can be taken to conserve more water.
6. Grey water or sewage recycled water should be used in toilets for flushing. This can reduce fresh water usage.
7. Awareness among students to conserve water campaigns has to be conducted.

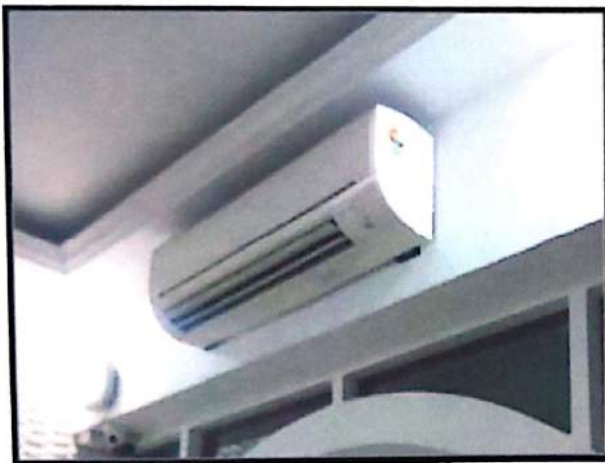
1. Every classroom and lab has a sufficient number of tube lights, LEDs and fans.
2. Air Conditioners used in campus are 1 star or 3 star. Few old ones have no stars.
3. UPS systems are provided to all computer equipped labs to prevent unexpected disruptions due to power cut.
4. All computers have LED screens. Signages are put on the wall to shut down PCs when not in use.
5. Signages are also provided beside switch boards to switch OFF lights and fans when not in use to encourage users to save electricity.
6. Many of the conventional tube lights are replaced with LEDs.

Air Conditioners Installed in Lab

1. Diagrams are recommended at every switch board to point the correct tube light and fan.
2. Old Air Conditioners without stars need to be replaced.
3. New electronic devices while purchasing should have star ratings as per BEE (Bureau of Energy Efficiency).
4. Light reflectors should be used so that the light is spread to large area and also reduces electricity consumption
5. Control sensors can be used to dim the light automatically when people are not around.
6. Emergency Exit Signage is required

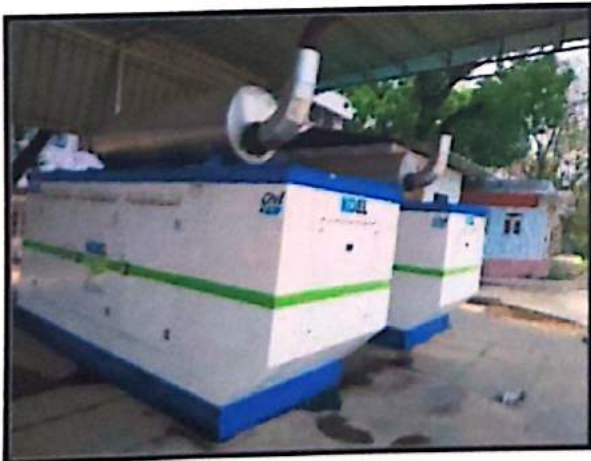
1. LPG gas are used in canteen for cooking
2. 2 diesel generators of 250 KVA for backup have been installed for emergency power failure.
3. Renewable energy is used by Solar panels of 10 KWP installed on rooftops. This energy is used for street lights within the campus.

2 Diesel Generators

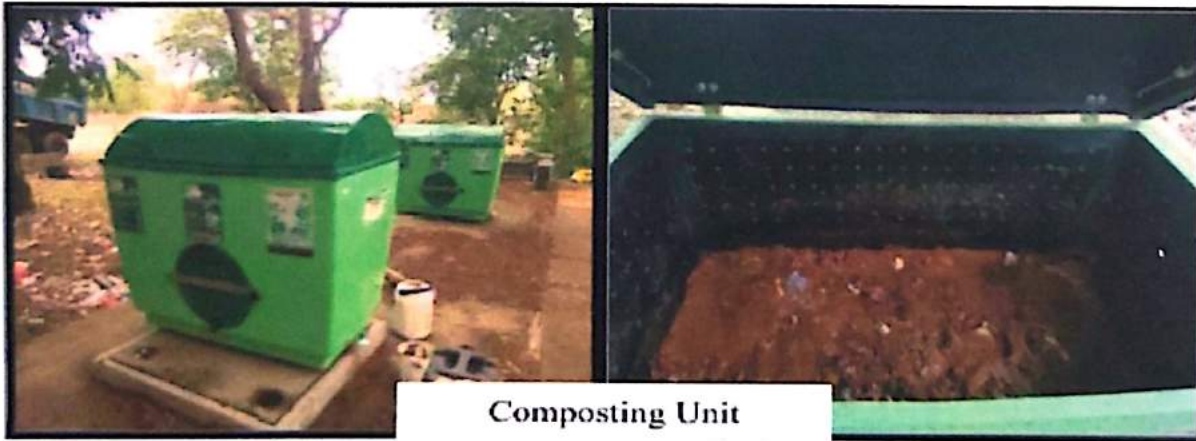
1. Separate bins for wet and dry waste are found in the canteen.
2. Almost 50 kgs of dry and wet waste is generated by the canteen.
3. Campus has installed a composting unit to deal with these wastes.
4. In other areas like classrooms, staff rooms or offices mostly paper waste or plastic wastes are generated.
5. Dust bins are found in every corner of every classroom.
6. Signages were found near a few dustbins.

Composting Unit

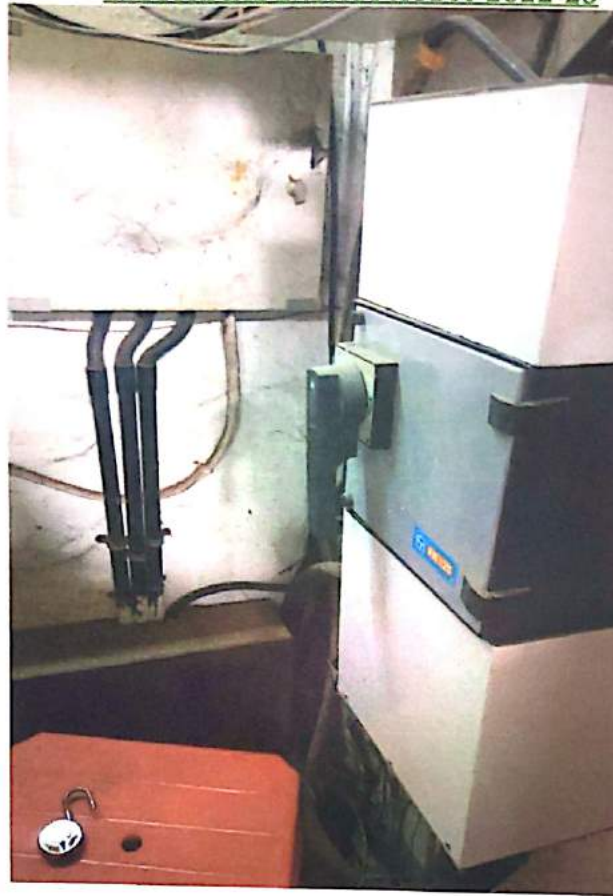
Main Electric panel

1. Electrical single diagram is not found,
2. Emergency Contact Details,
3. Electric room is labeled with "Electric Room" "Danger 440 Volts" "Restricted Entry".
4. 5Kgs, CO2 type fire extinguisher is providing.

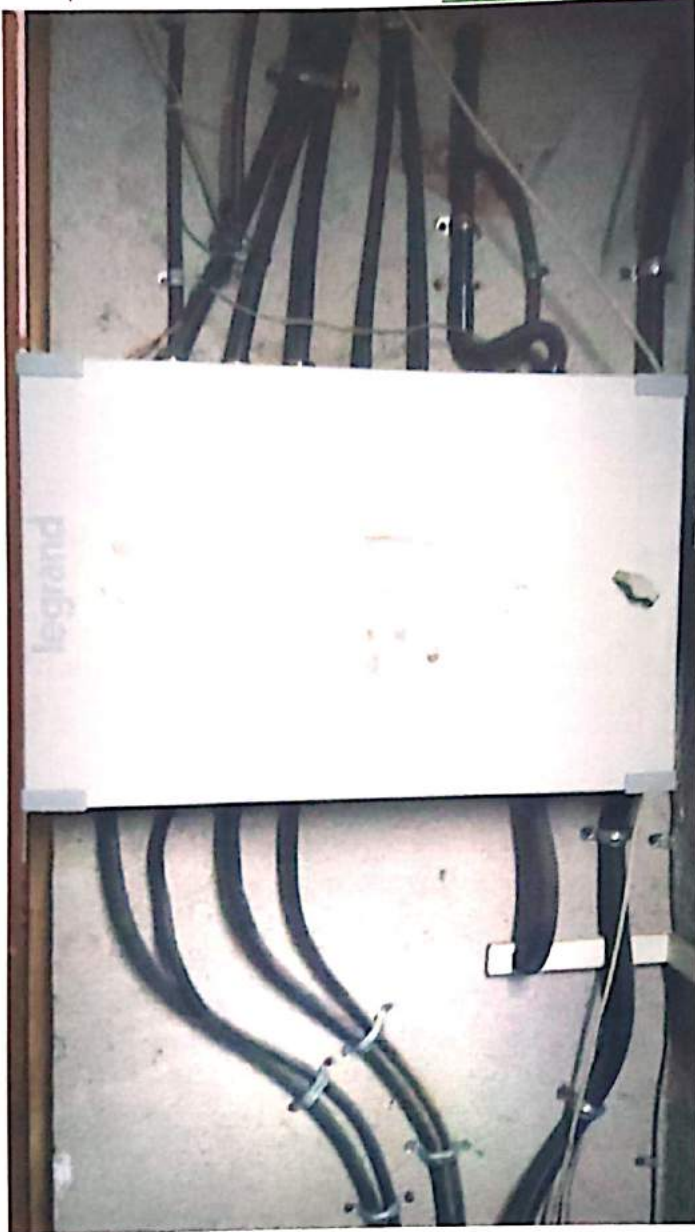
Kindly get the tag installed for proper identification of cables.
Electric room is labeled with "Electric Room" "Danger 440 Volts" "Restricted Entry"

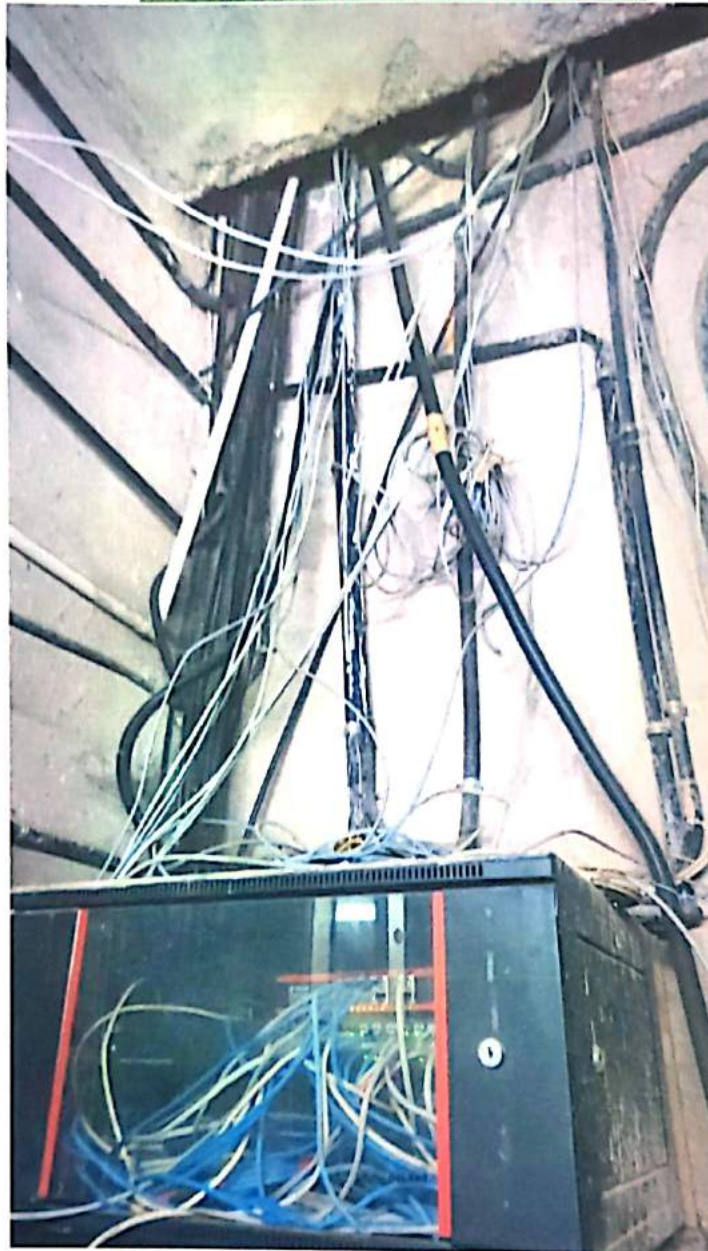
Kindly get the tag installed for proper identification of cables.
Electric room is labeled with "Electric Room" "Danger 440 Volts" "Restricted Entry"

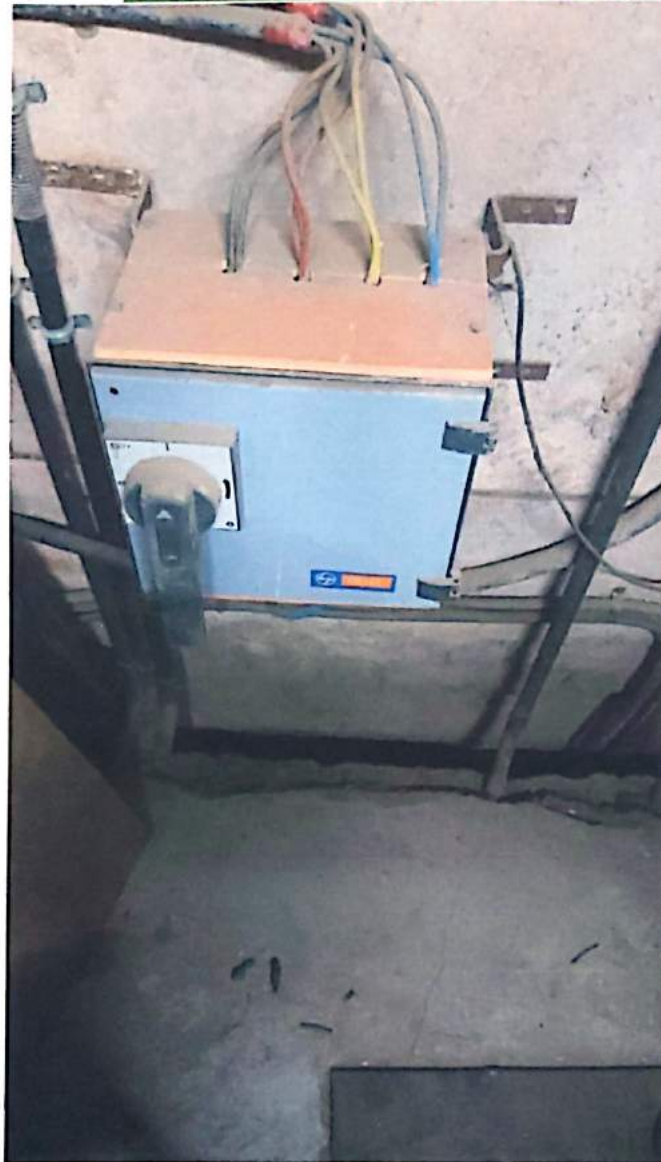
Electrical Insulating mat is provided on flooring.

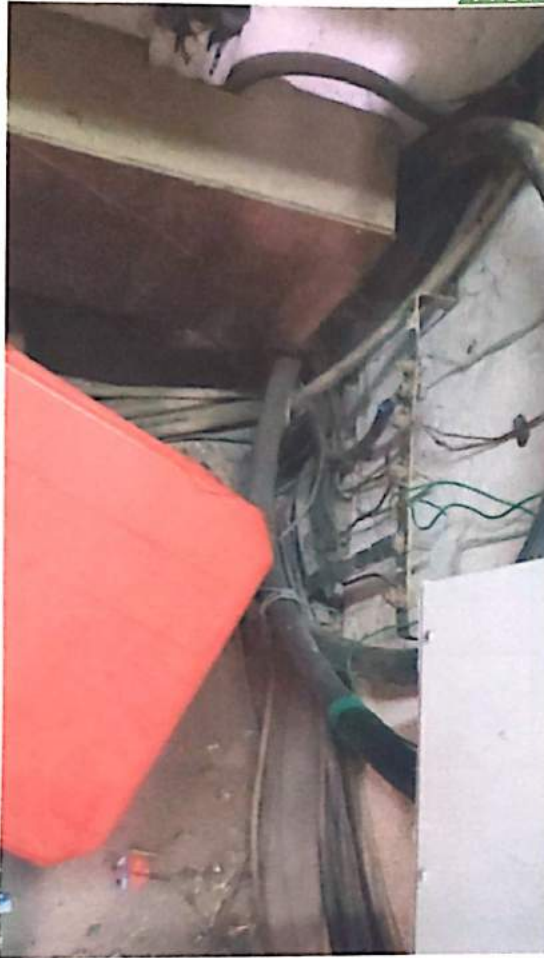
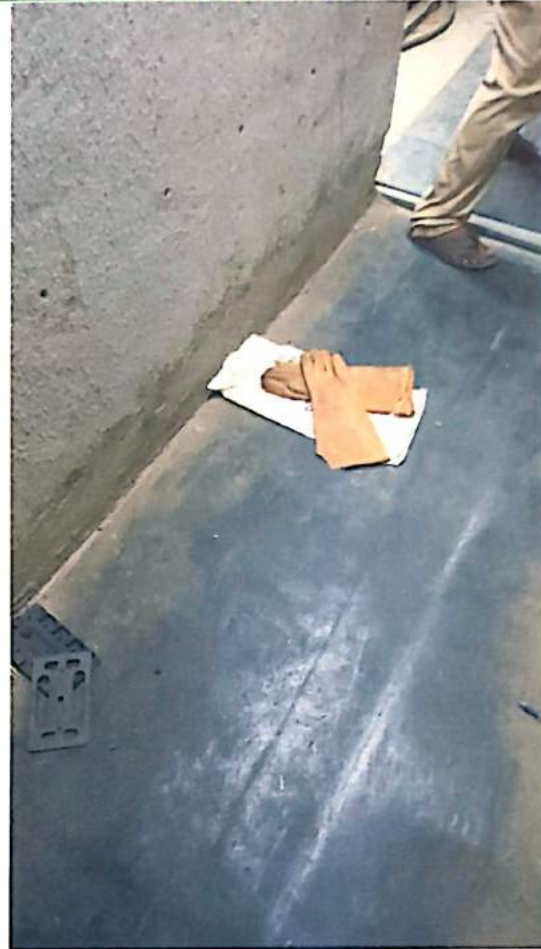
Unwanted material found in panel room.
Earthing bolts was Rusted.

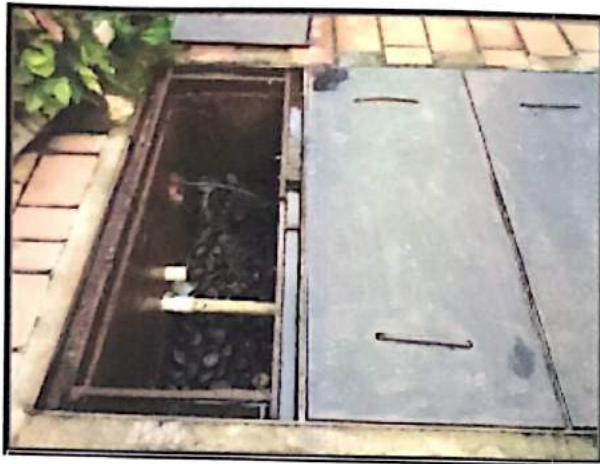
Rainwater Harvesting System- Recharge Pit

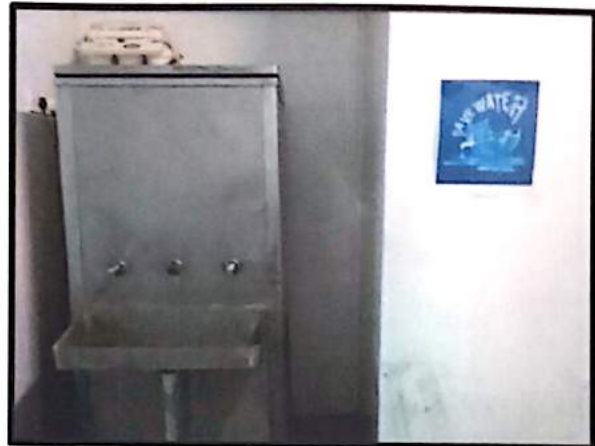
8. Water saver faucets are installed in few washrooms
9. Water leakages are attended and maintained on time by inhouse team.
10. Signages are provided at a few water points.

Signages near Cooler/Purifier

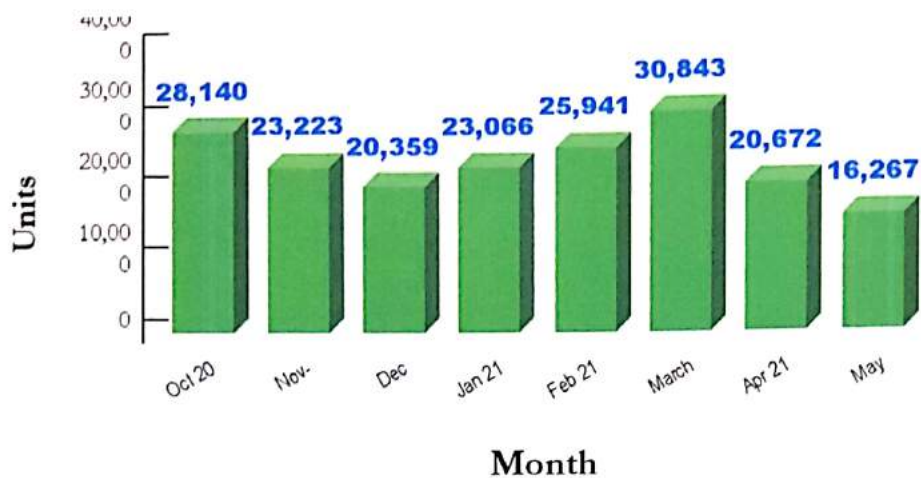
Monthly Energy Consumption from Oct 2020 to May 2021

The consumption is found to be too low because of lockdown in this pandemic. Going through the previous report and bills it is found that the average energy consumption is 53,220 KWh(units).

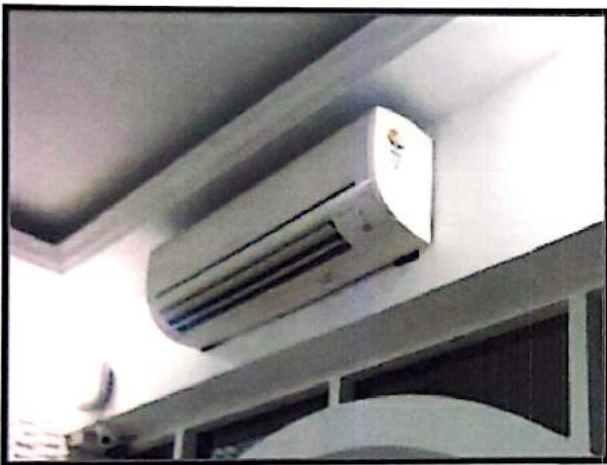
1. Every classroom and lab has a sufficient number of tube lights, LEDs and fans.
2. Air Conditioners used in campus are 1 star or 3 star. Few old ones have no stars.
3. UPS systems are provided to all computer equipped labs to prevent unexpected disruptions due to power cut.
4. All computers have LED screens. Signages are put on the wall to shut down PCs when not in use.
5. Signages are also provided beside switch boards to switch OFF lights and fans when not in use to encourage users to save electricity.
6. Many of the conventional tube lights are replaced with LEDs.

Air Conditioners Installed in Lab

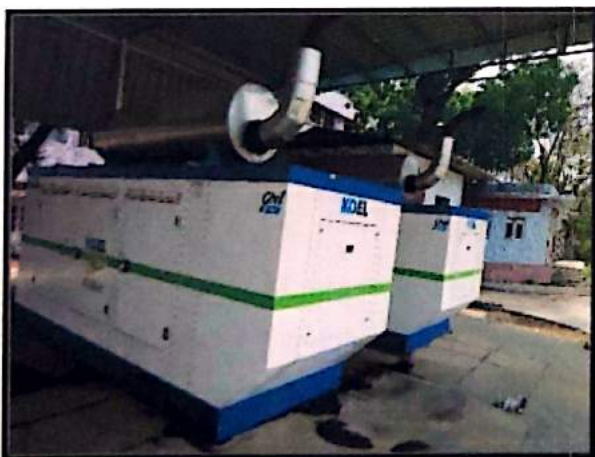
1. LPG gas are used in canteen for cooking
2. 2 diesel generators of 250 KVA for backup have been installed for emergency power failure.
3. Renewable energy is used by Solar panels of 10 KWP installed on rooftop. This energy is used for street lights within the campus.

2 Diesel Generators

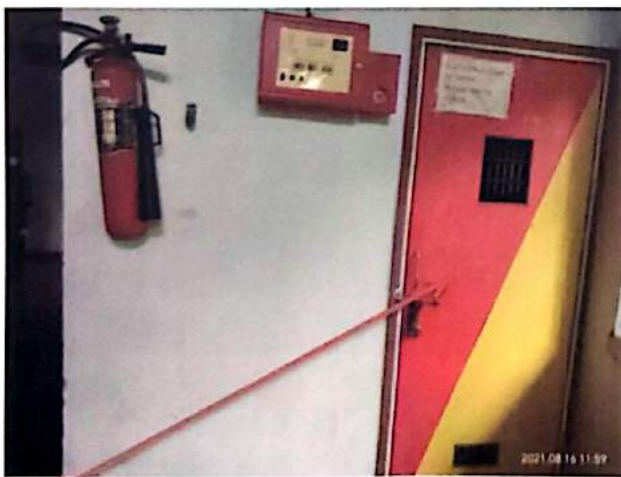
Shock treatment charts not displayed in panel room,

Fire schematic not mentioned at of DB

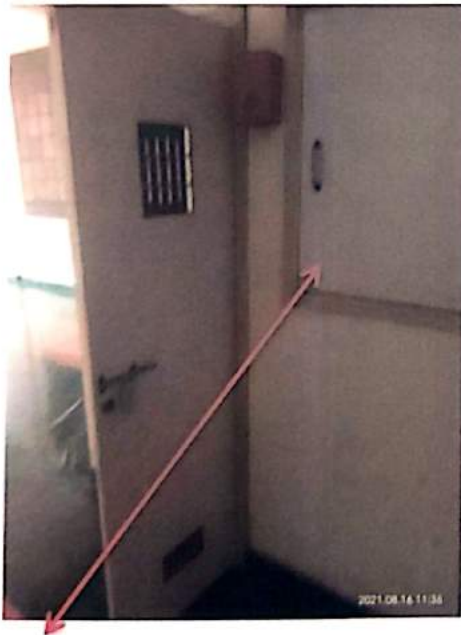
1. Electrical single diagram is not found,

2. Emergency Contact Details

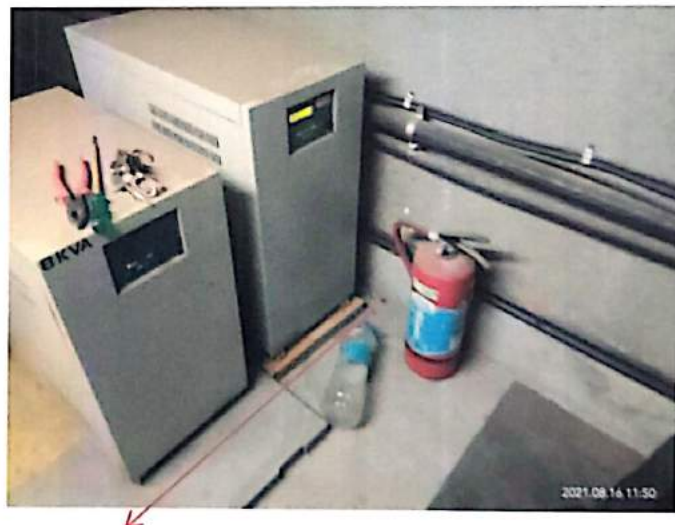
Fire extinguisher are provided but 5 ft. on wall mounted

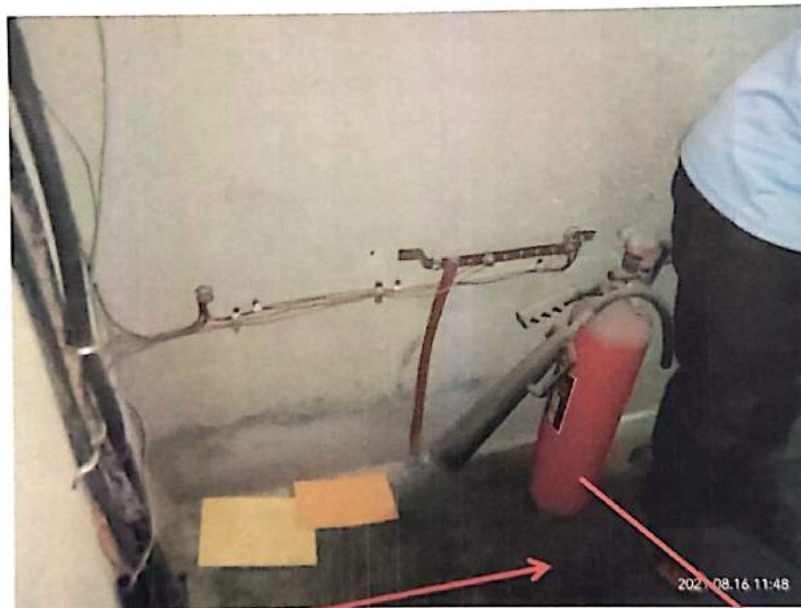
- 1- Electrical Insulating mat is not founding on flooring.
- 2- Fire extinguisher are provided but 5 ft. on wall mounted

- 1- Electric DB is labeled with "Electric Room" "Danger 440 Volts" "Restricted Entry"

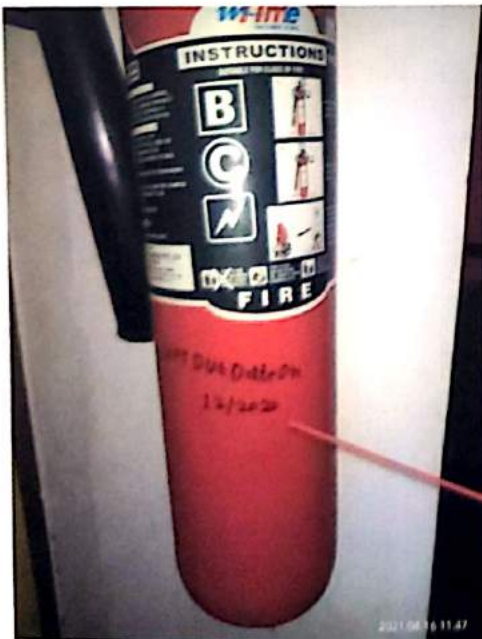
Fire extinguisher was not renewing

Unwanted material is stored in electrical & fire panel area
